MERRITT &amp; HARRIS, INC.

20-251E

Re: **World Trade Center**  
**New York, New York**

One World Trade Center

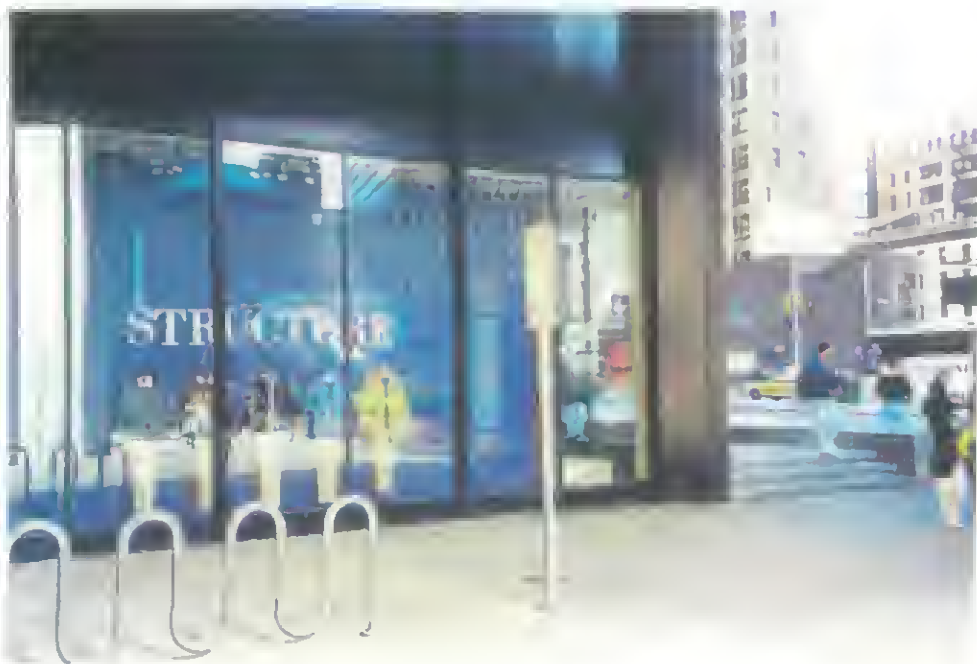
**Photograph 26**

Retail showcase  
windows at  
Liberty Street  
side

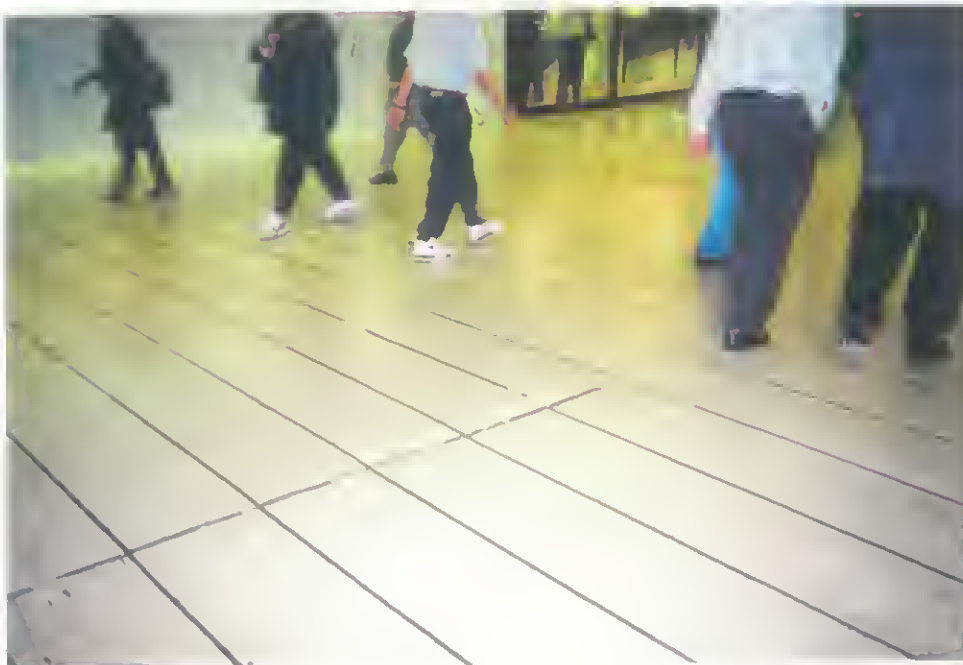
**Photograph 30**

Old travertine  
flooring in an  
area scheduled to  
be replaced with  
terrazzo

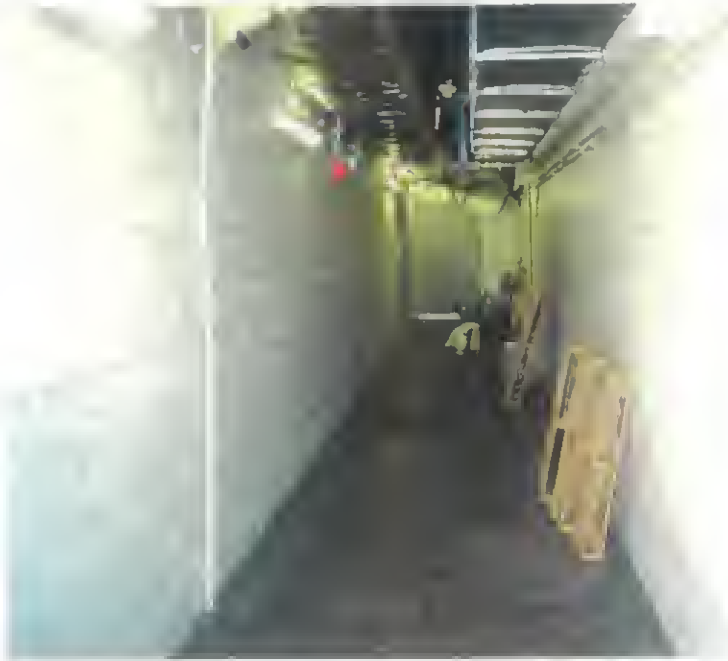
**Photograph 49**

Rear service  
corridor at  
Concourse level  
east side

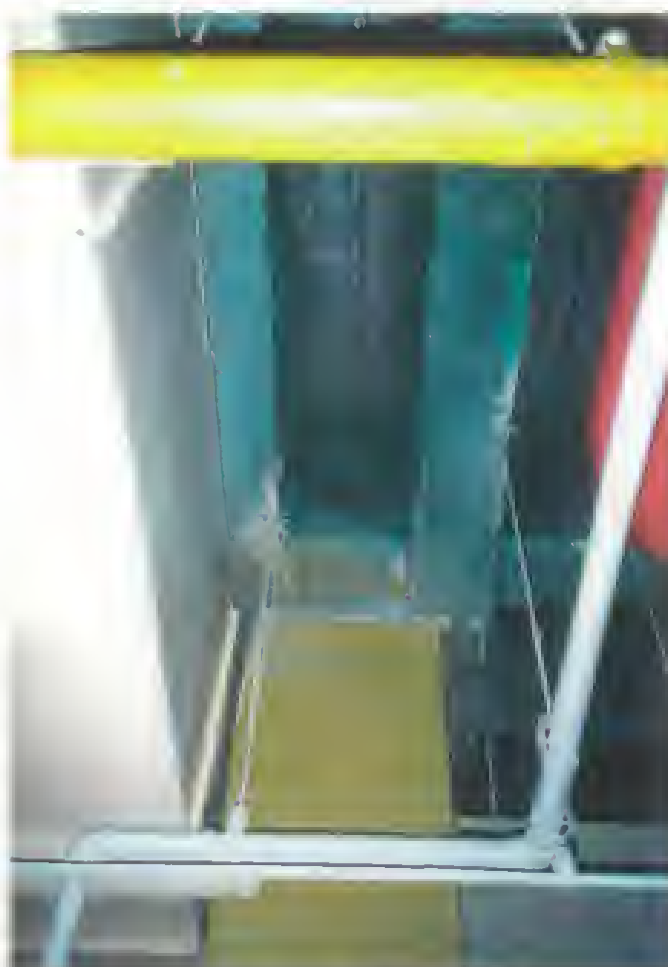
**Photograph 5**

**Double girder  
used on either  
side of column to  
frame cantilever**

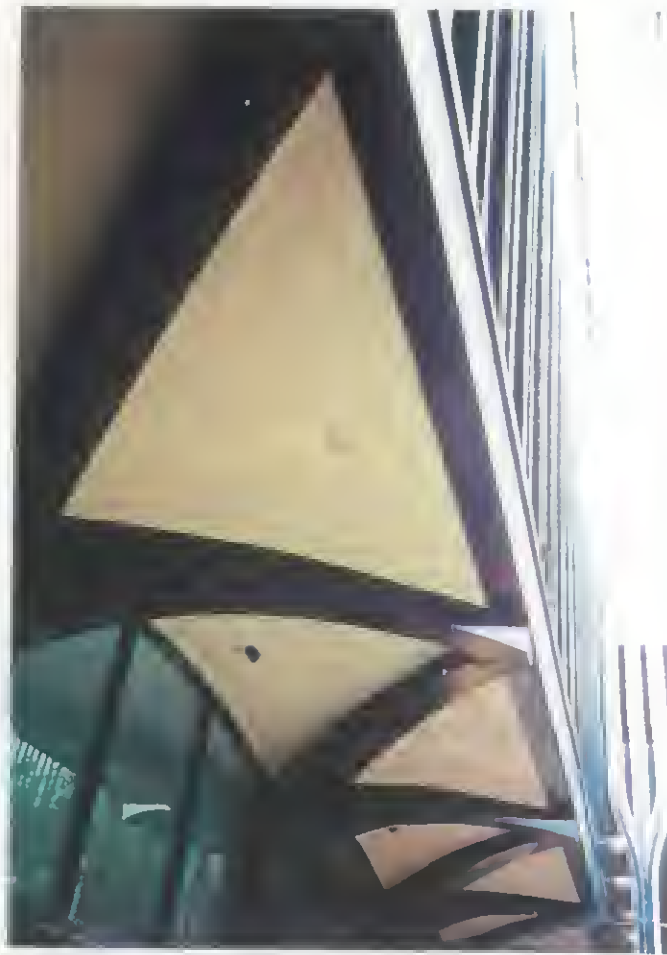
Photograph 7

Aluminum  
cladding conceals  
steel truss to  
support  
cantilever at 4th  
floor overhang

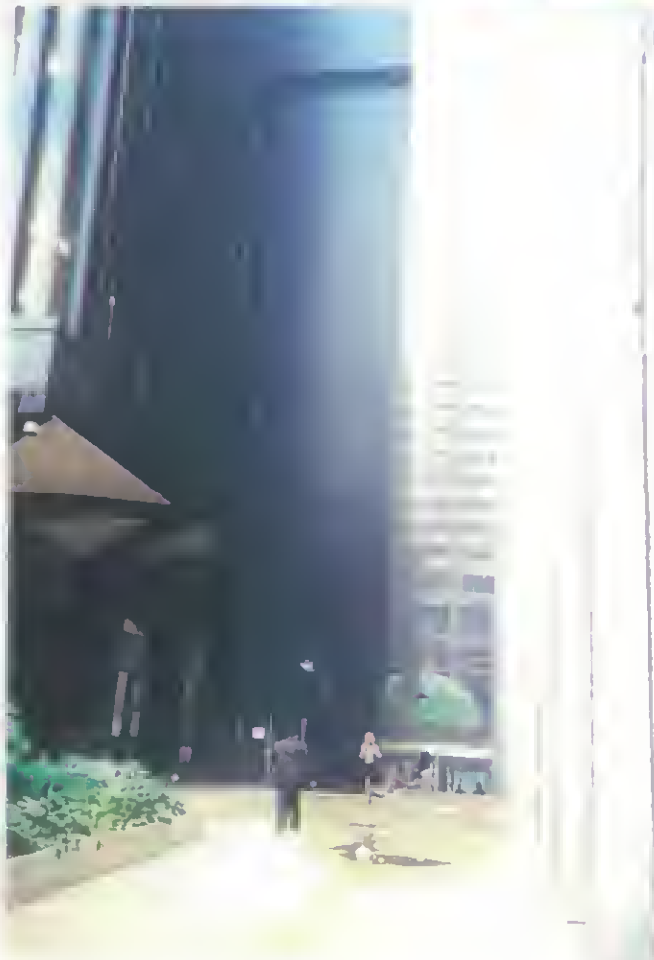
**Photograph 9**

North and west  
elevations from  
roof of 5WTC

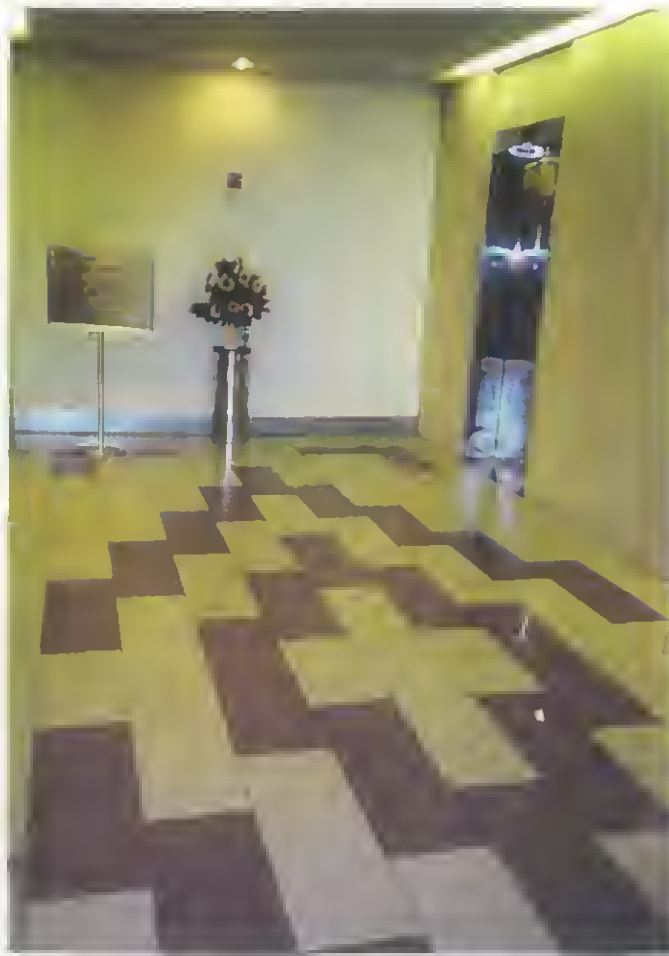
**Photograph 16**

Southeast stairway exiting into well at roof partially blocked by debris

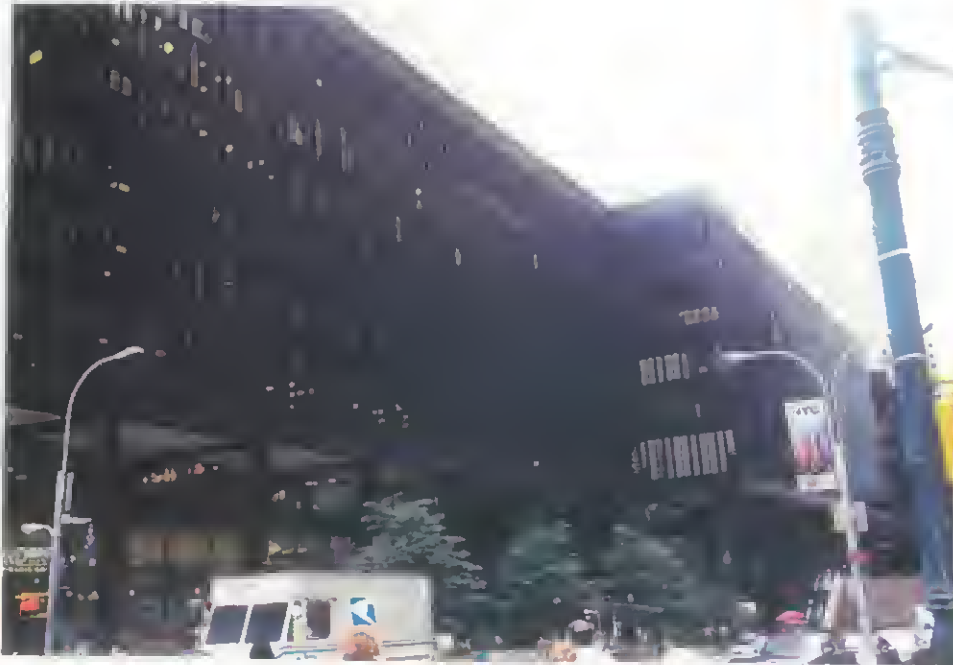
Photograph 9

North elevation

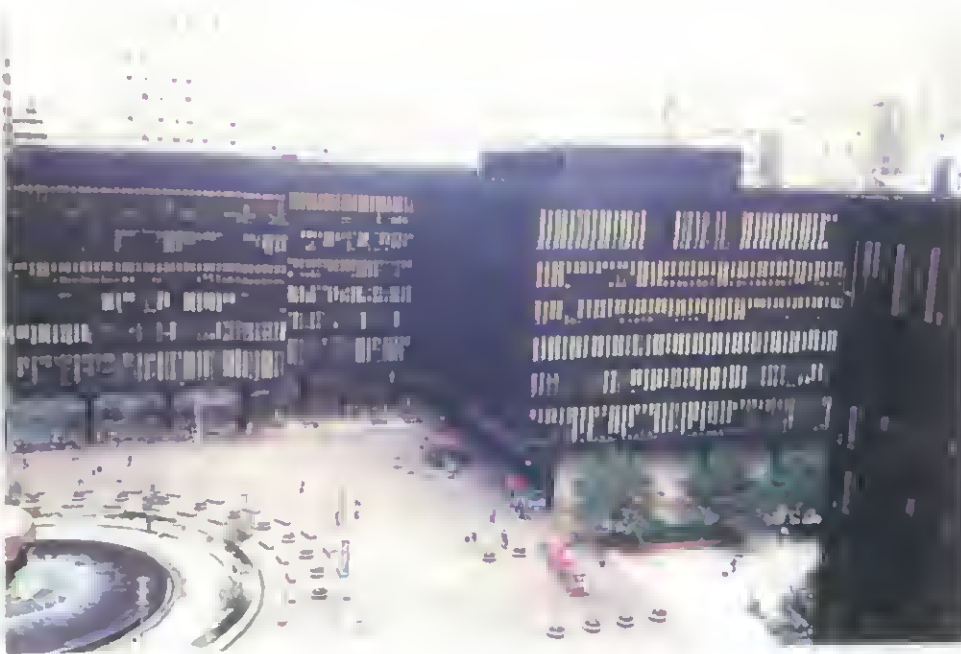
Photograph 10

South and west  
elevations from  
roof of 4WTC

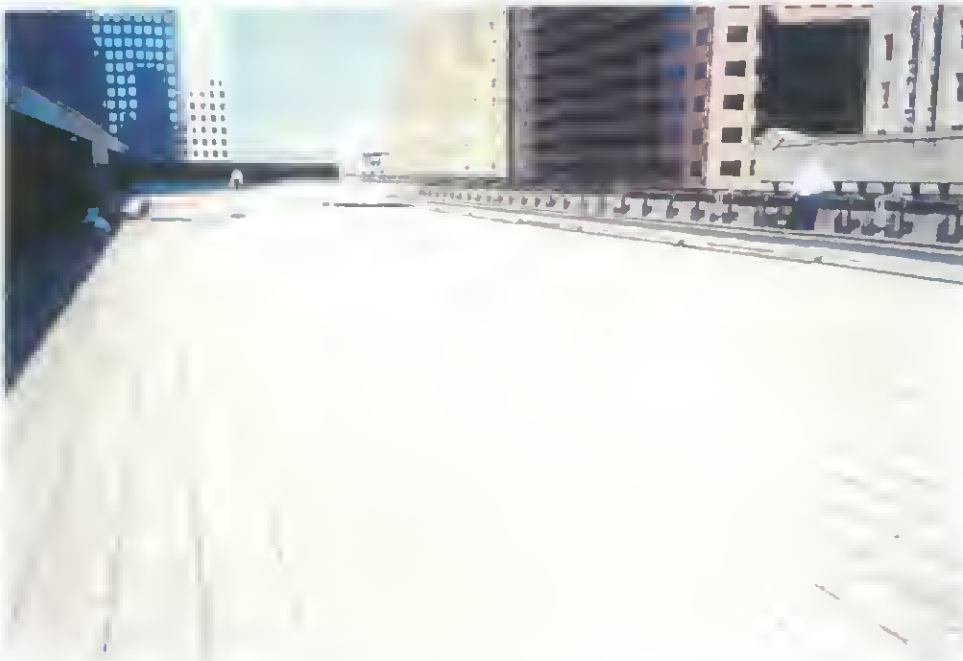
**Photograph 12**

**Main field of  
roof with  
mechanical  
penthouse,  
window washing  
rig track and  
parapets visible**

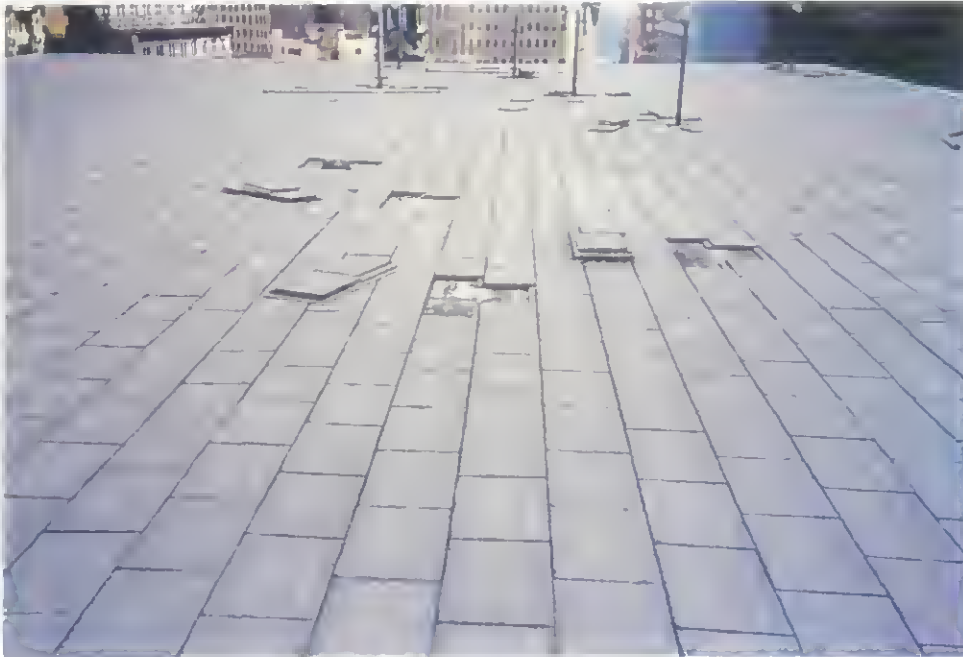
**Photograph 15**

**Penthouse roof  
with pavers  
removed for  
patching of  
membrane**

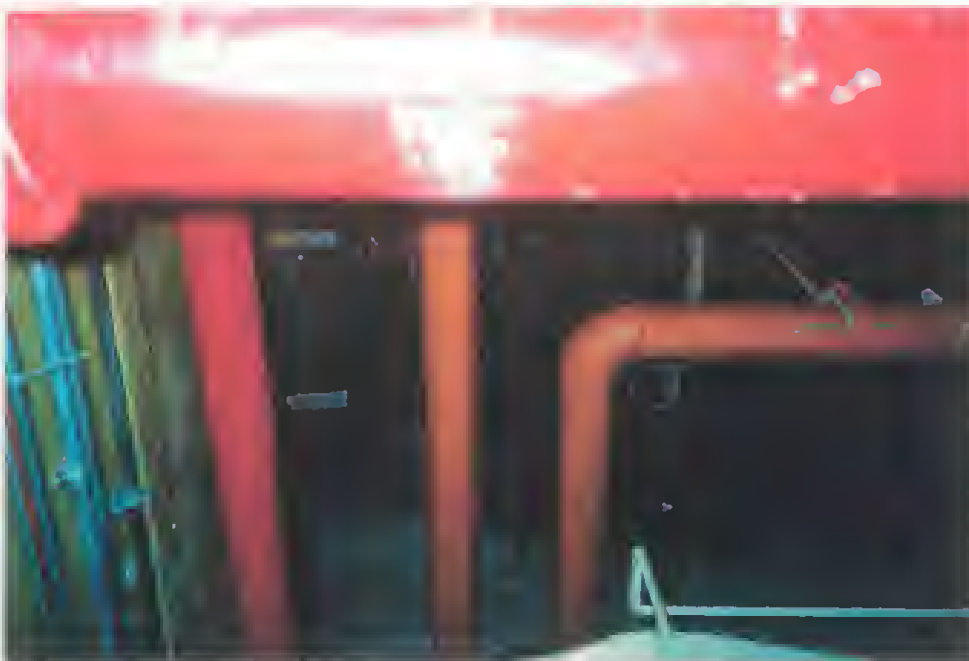
**Photograph 16**

**Severely rusted  
underside of roof  
deck from  
previous roof  
leaks**

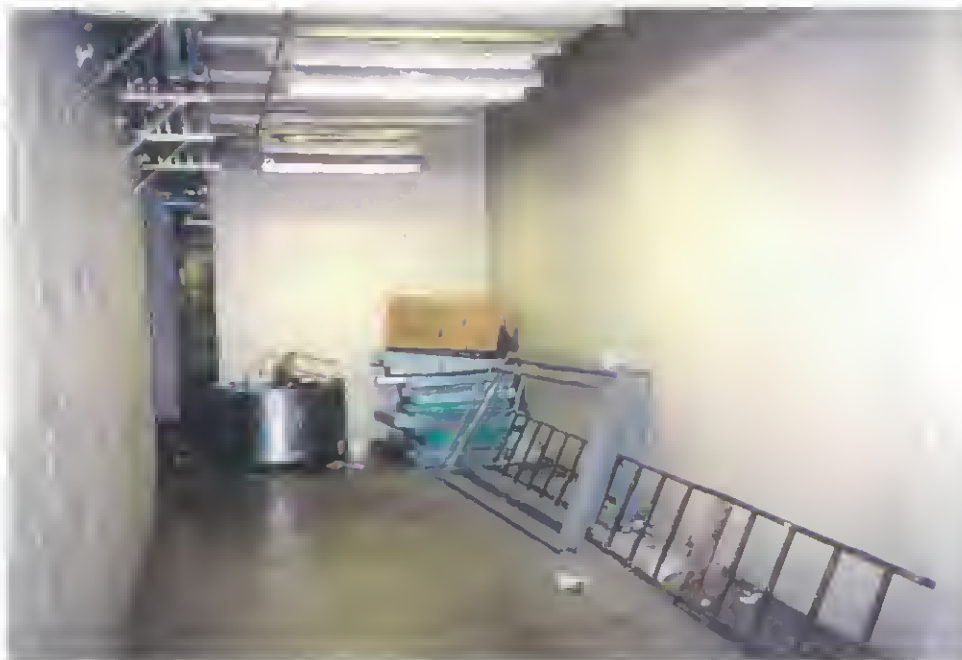
Photograph 28

Stored debris  
blocking  
corridor on B1  
level

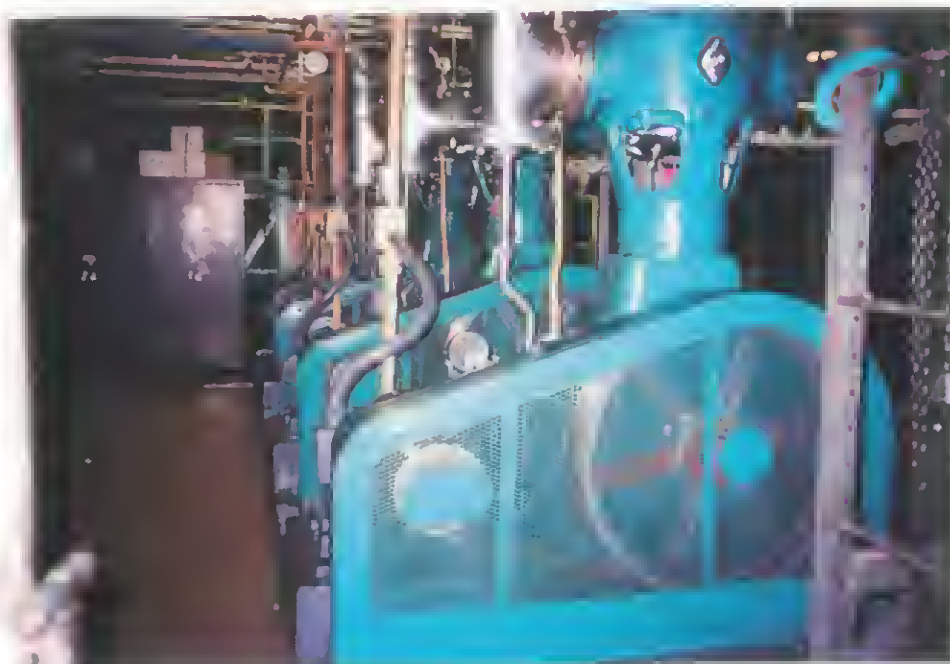
Photograph 12

Pneumatic  
control air  
compressors

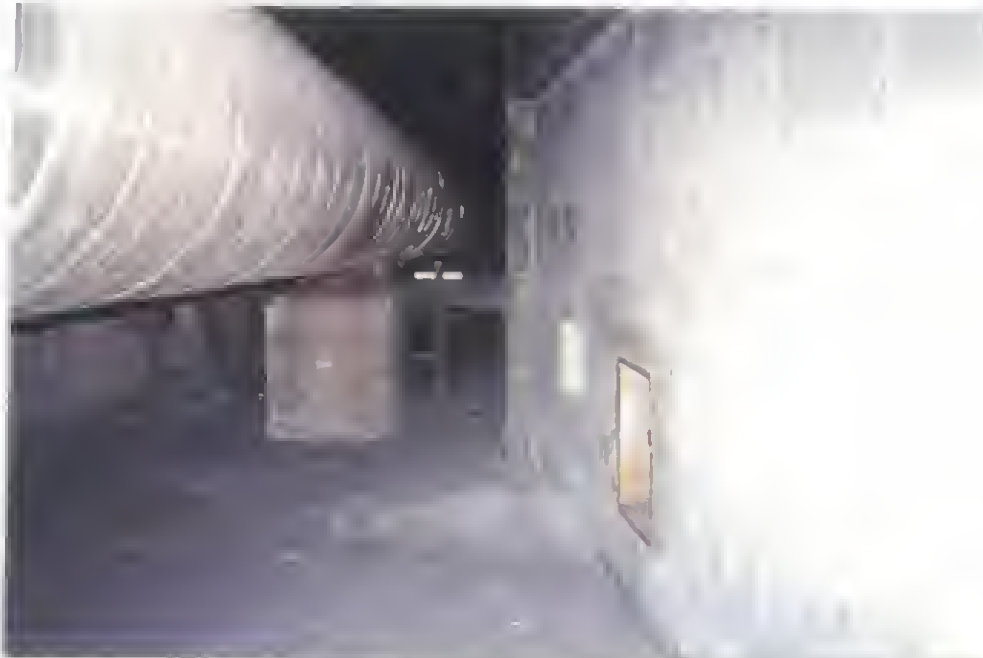
Photograph 13

Steam pipe rack

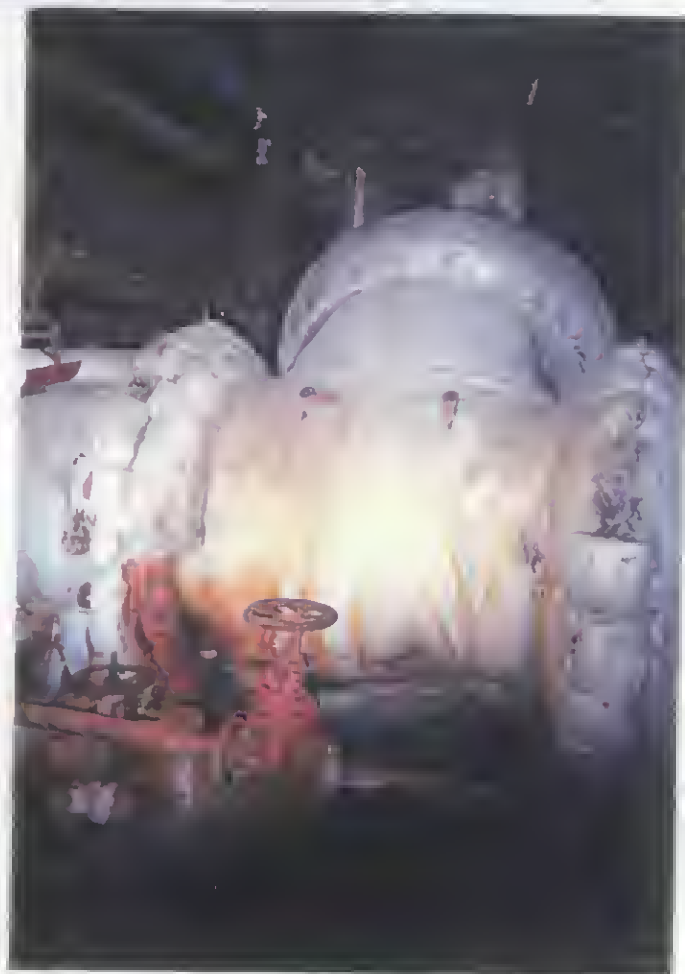
Photograph 14

Steam service  
valve (planned  
for replacement)

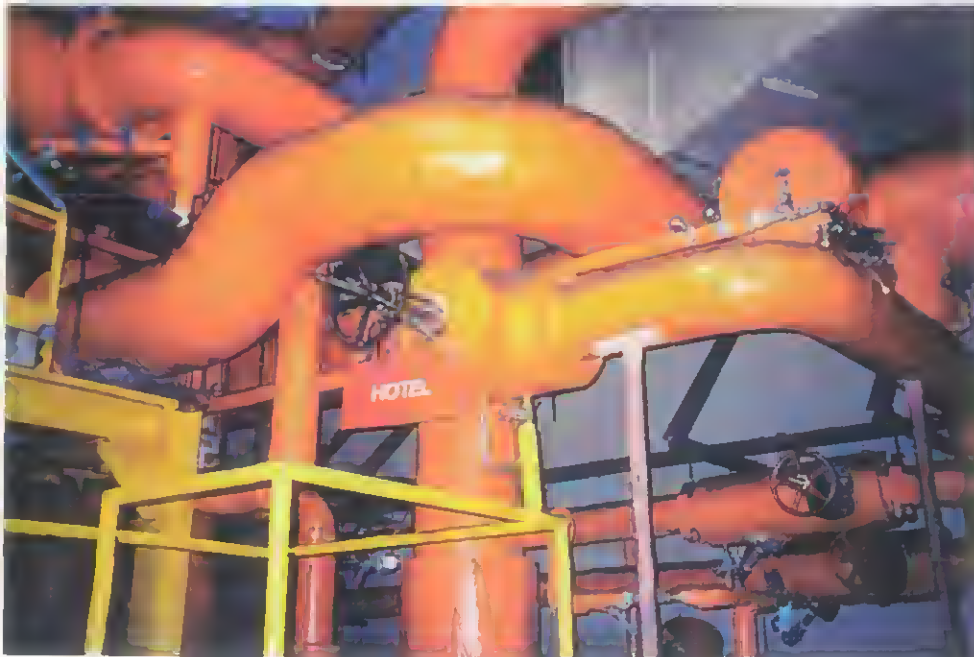
Photograph 15

Steam  
distribution  
plant

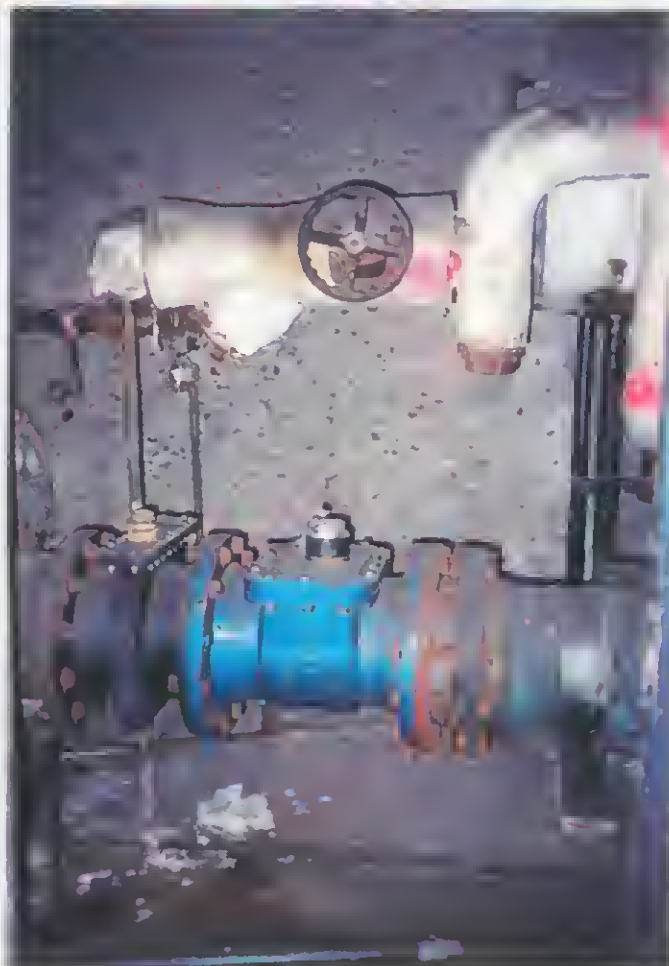
Photograph 16

One of the main  
water service  
meters

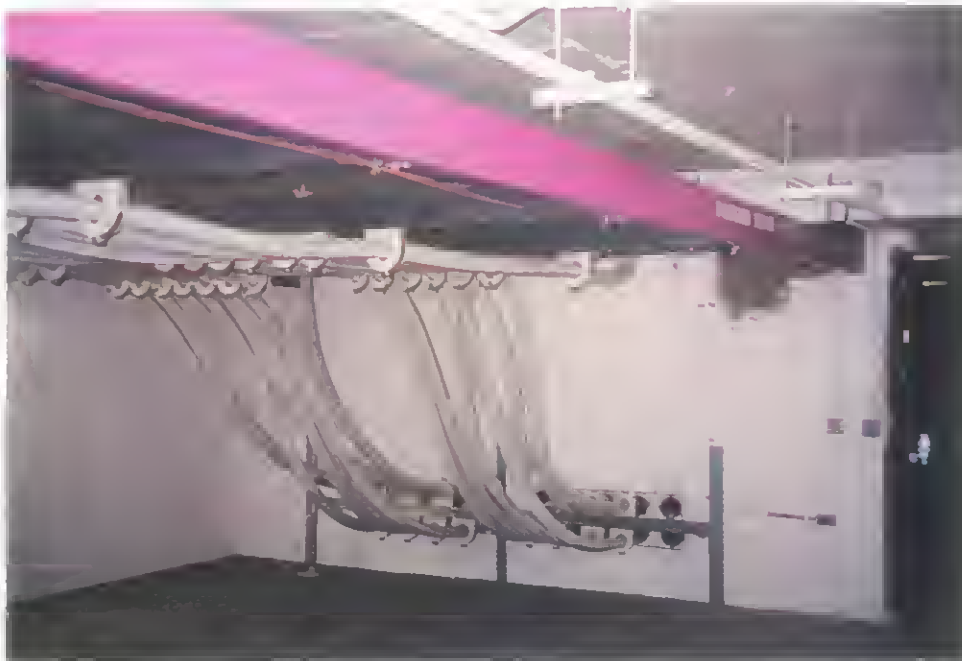
Photograph 18

Recently  
upgraded high  
voltage feeders

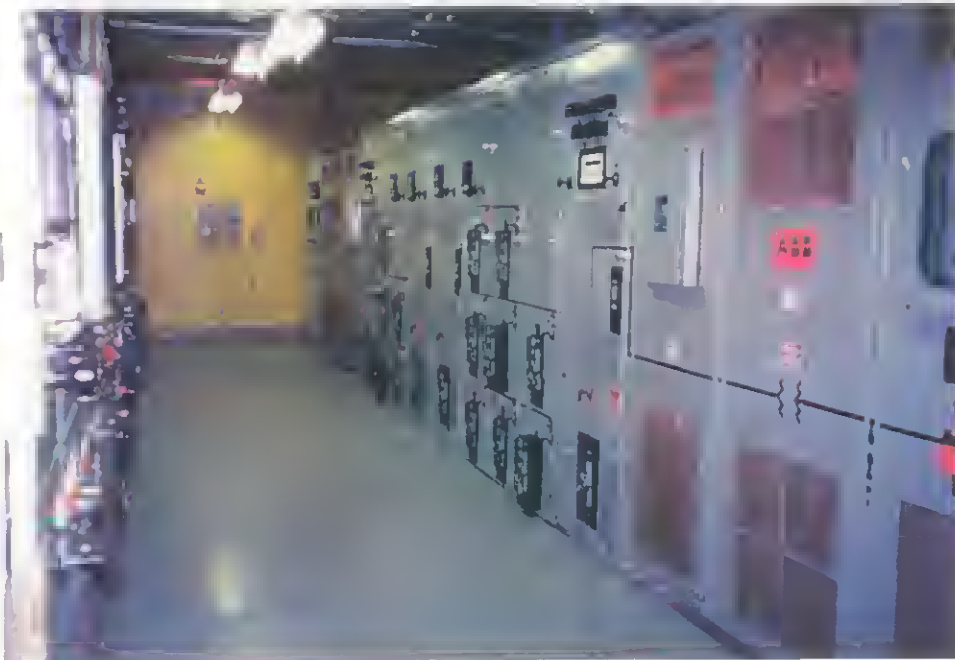
Photograph 19

Upgraded  
electrical  
substation

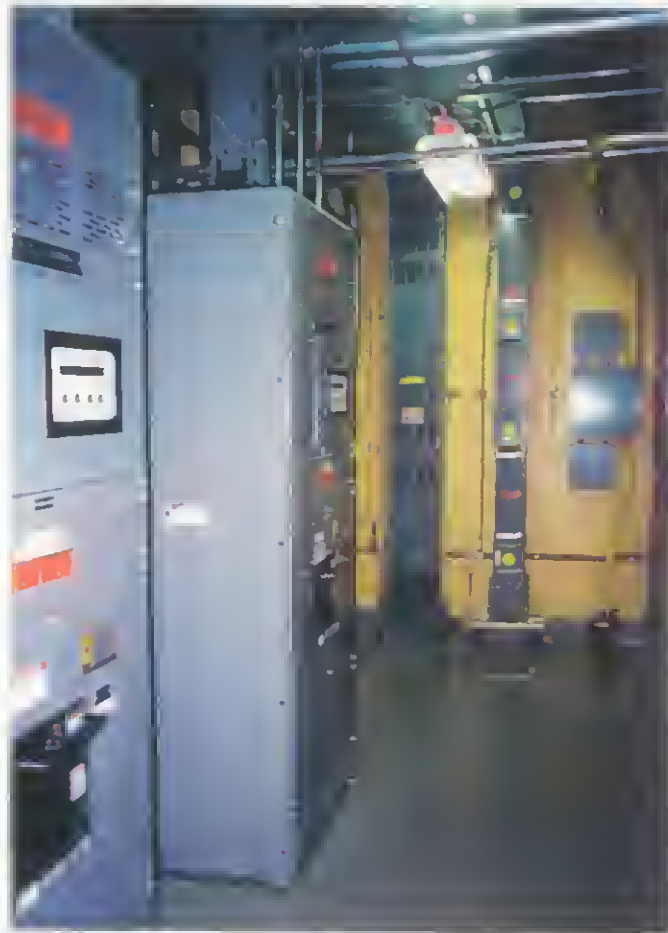
Photograph 20

Electrical  
distribution bus  
ducts (new and  
old) from a  
substation

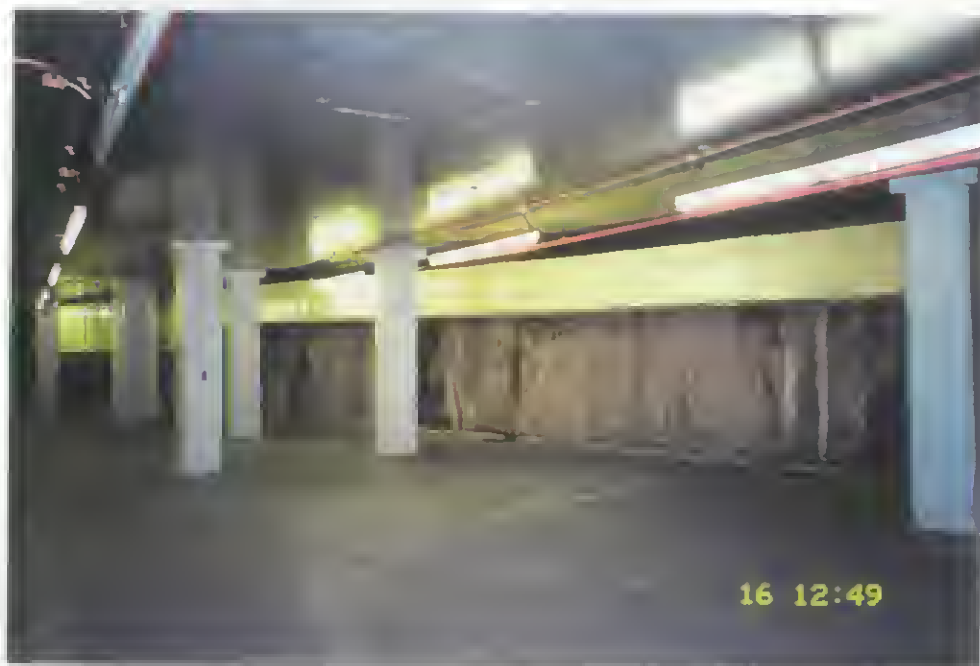
Photograph 1

Slurry wall exposed  
in Level B5

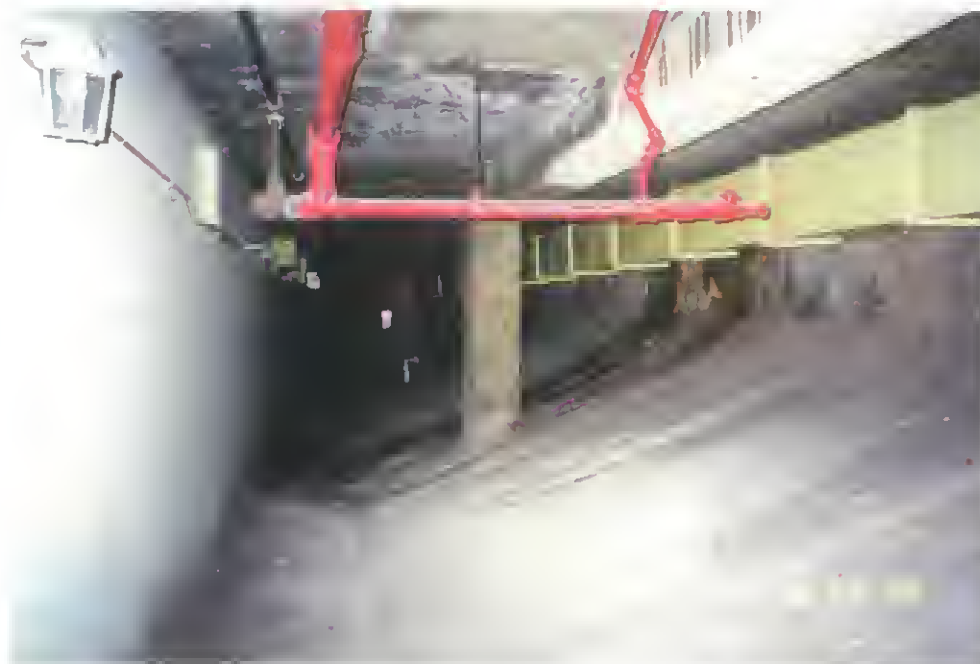
Photograph 2

Base of slurry wall -  
Level B6

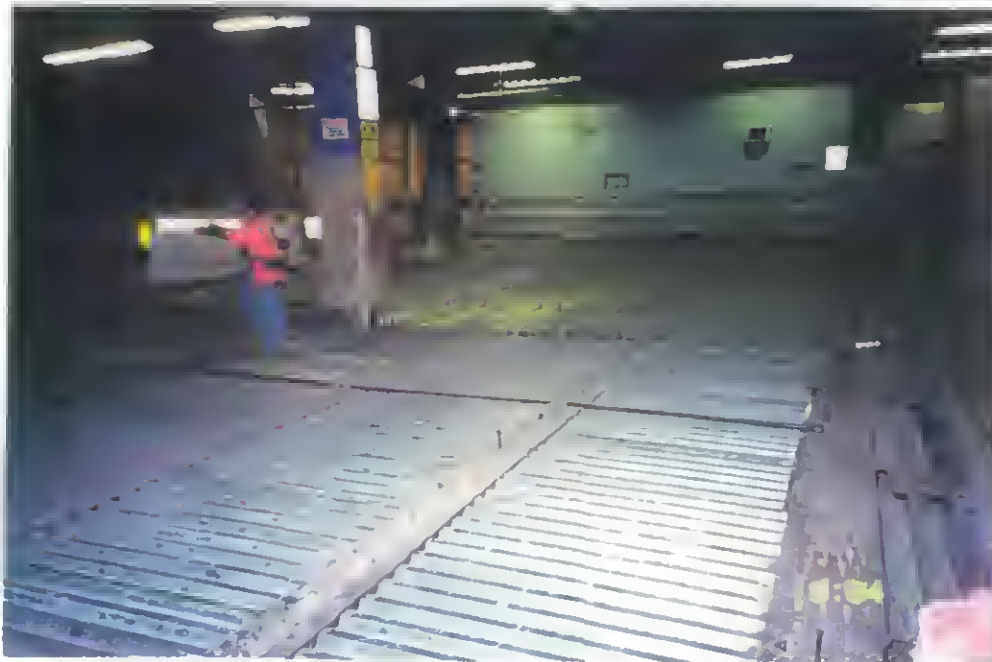
**Photograph 10**

Loading dock area

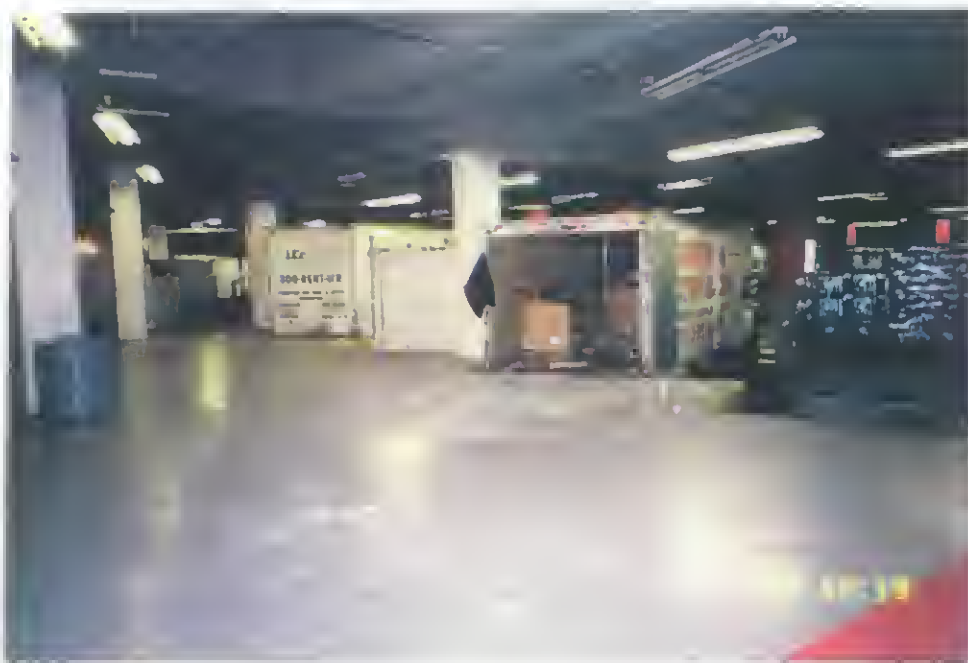
Photograph 11

Loading dock area  
for US Customs  
Buildings

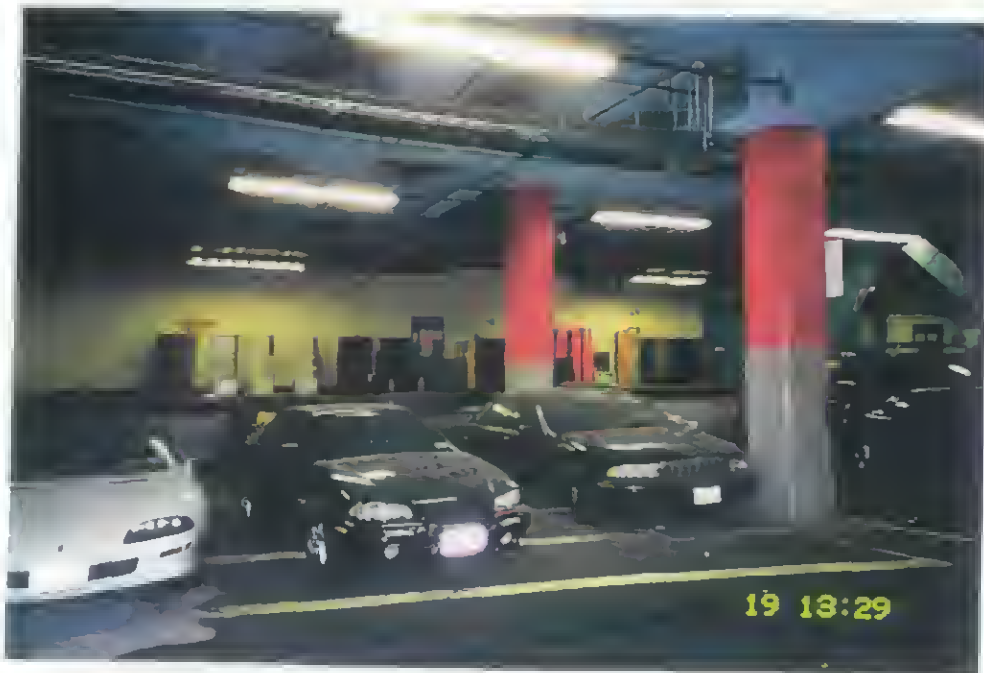
Photograph 12

Missing fireproofing  
at loading dock

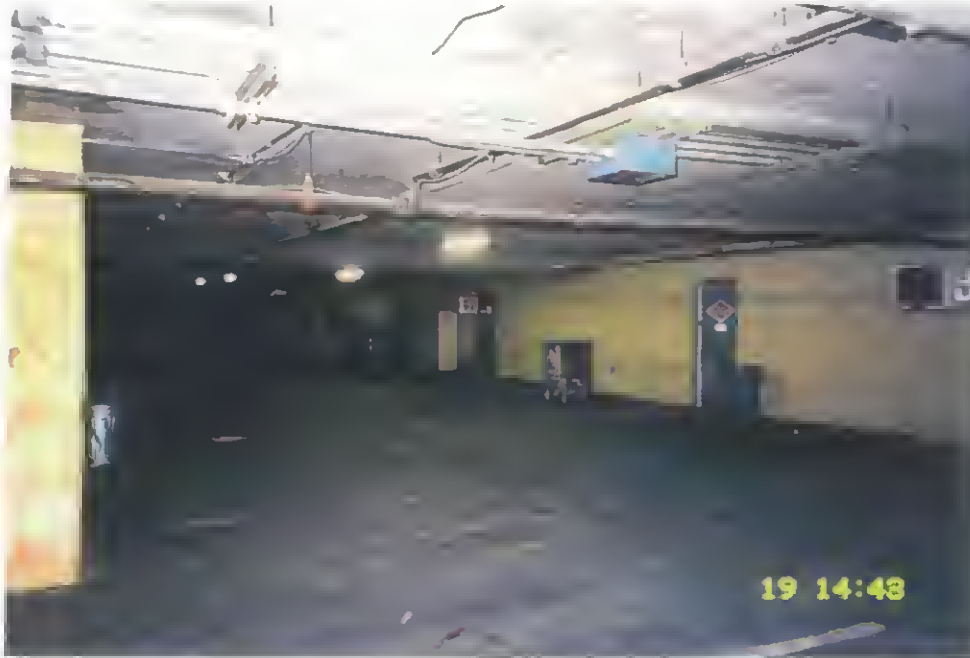
**Photograph 16**

Repairs of ceiling  
slab at B2 ceiling  
due to bomb  
explosion

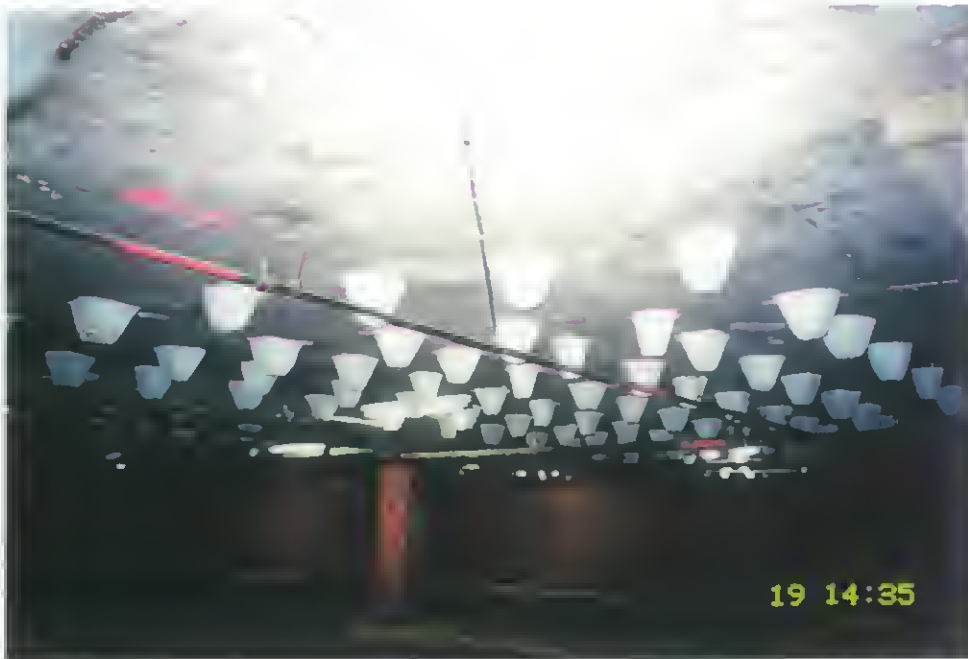
Photograph 17

Repairs at column  
brackets to support  
weakened slabs

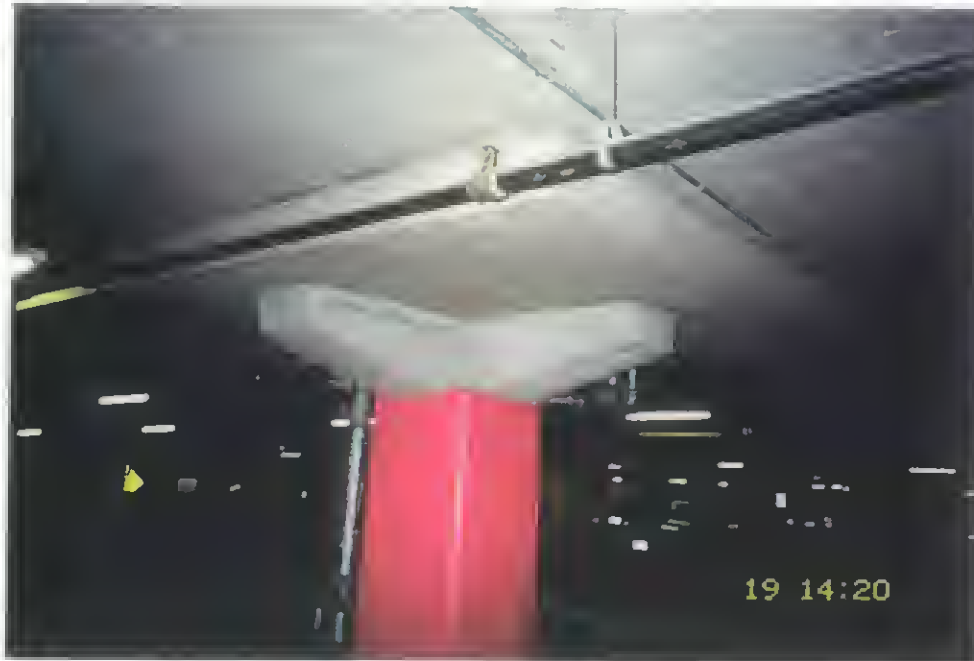
Photograph 18

New ceiling slab  
installed above  
refrigeration plant  
due to bomb blast

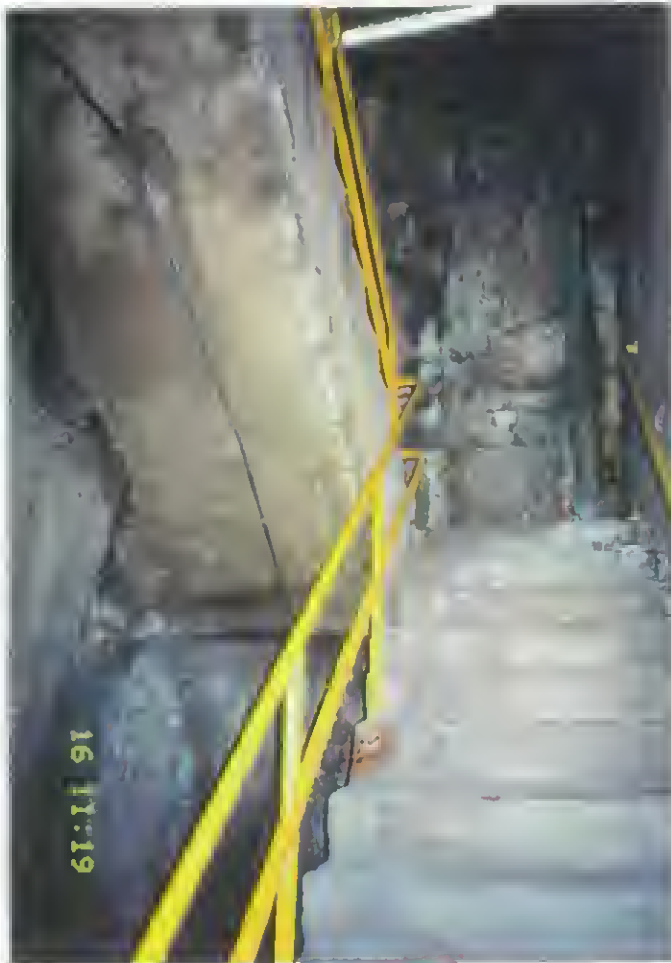
Photograph 22

Typical subgrade  
stair requires  
cleaning and  
some require  
painting

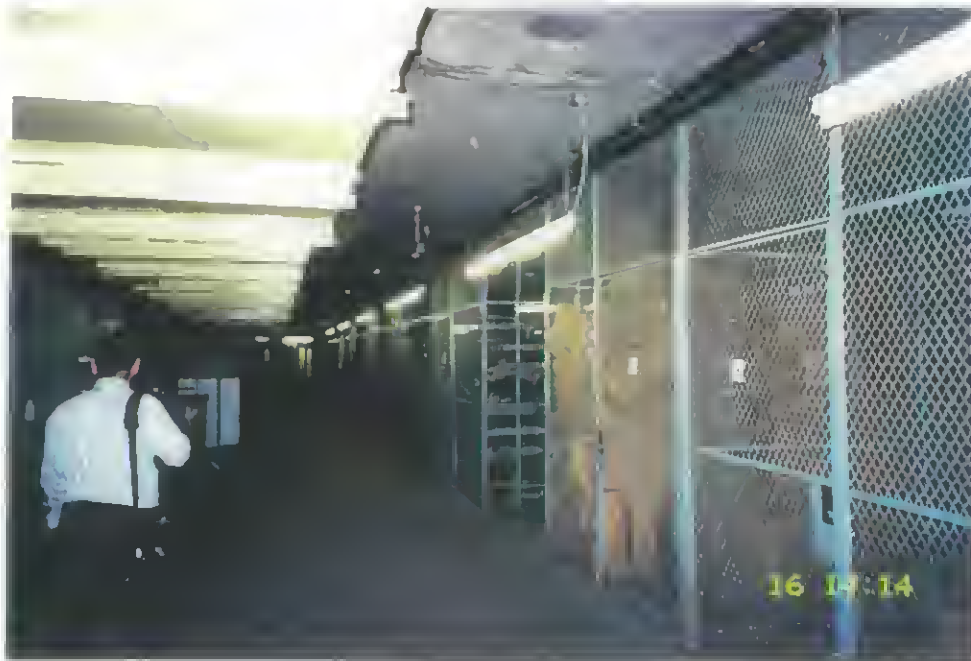
Photograph 24

B4 northeast stair  
door being replaced
